INNOVATION IN ACTION

Hwy. 1/Mud Creek
Monterey County

PM 8.9

May 20th Landslide

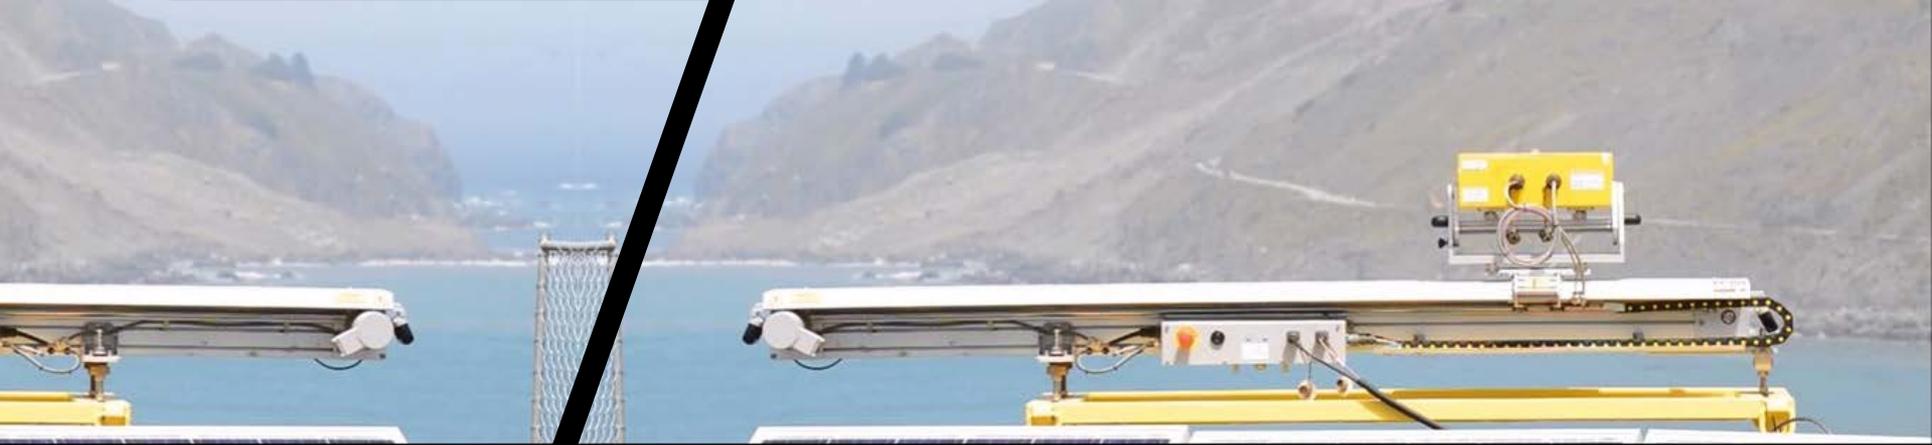
Innovative Initial Response – IDS Radar

Radar was used on-site to scan the slopes in and around the landslide; information from scans taken every 3 minutes provided data on movement.

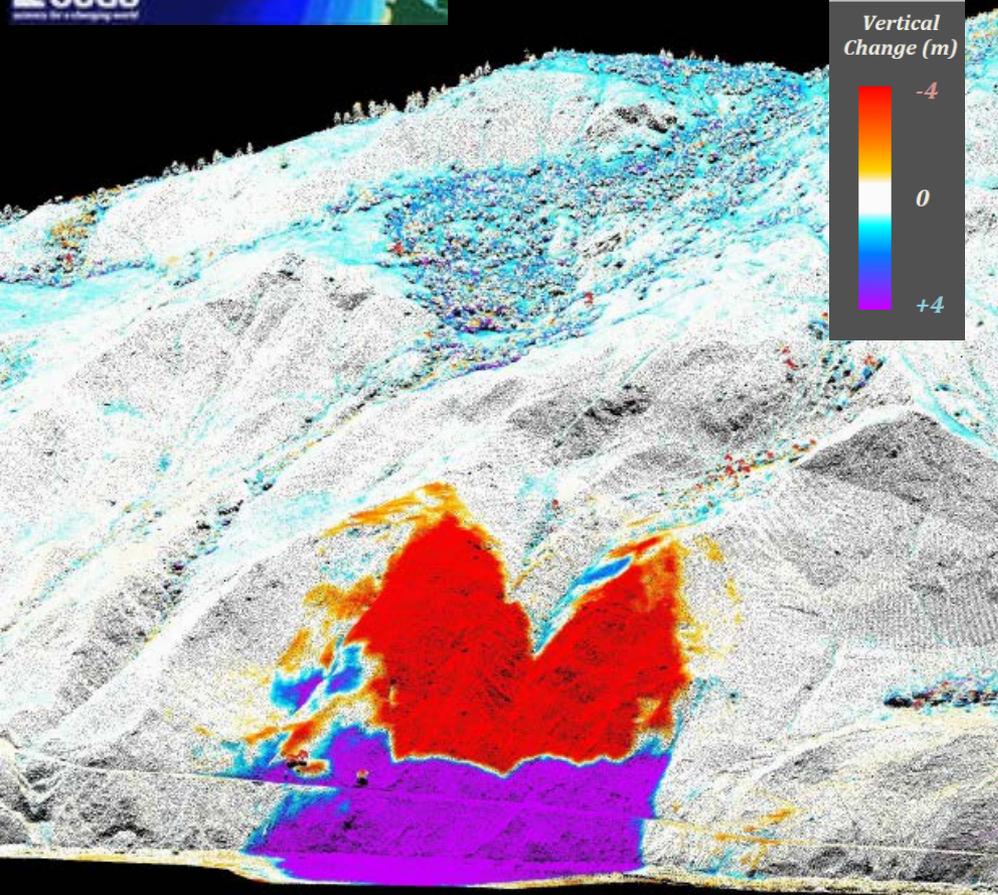
- USGS Photogrammetry

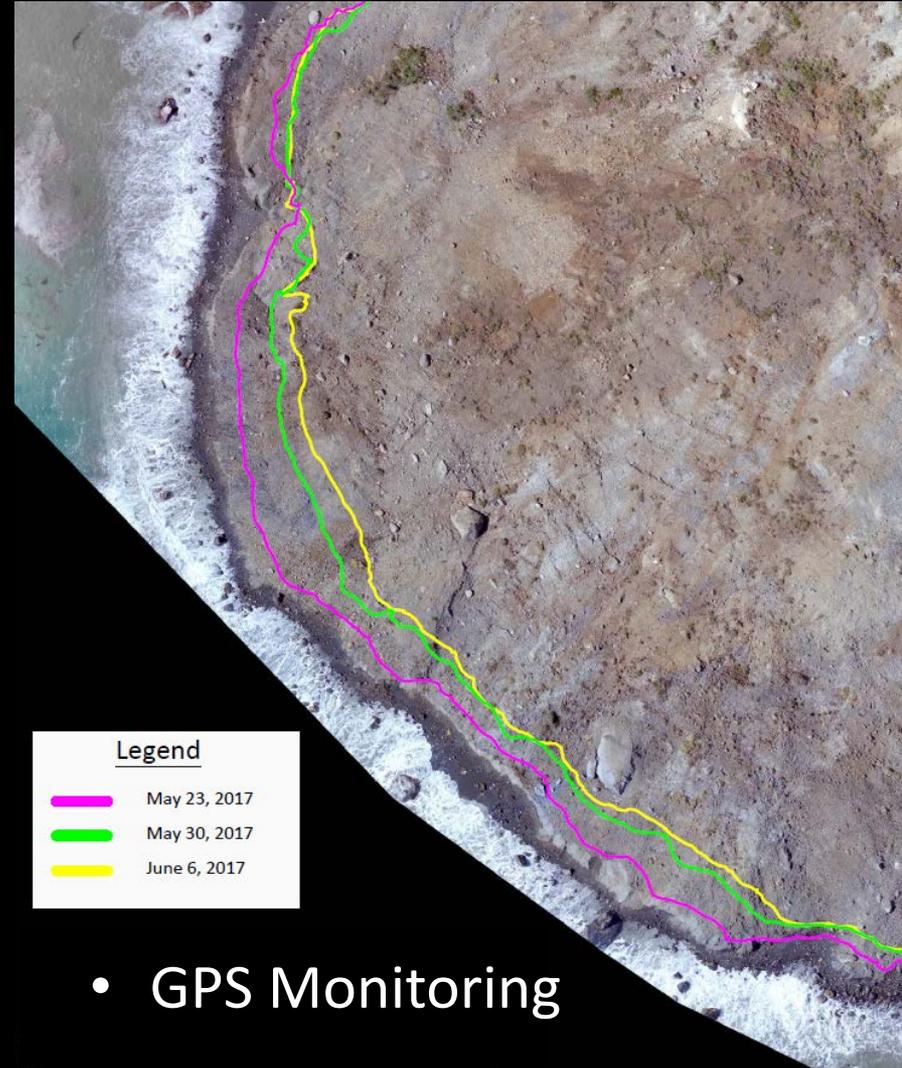
- GPS Monitoring

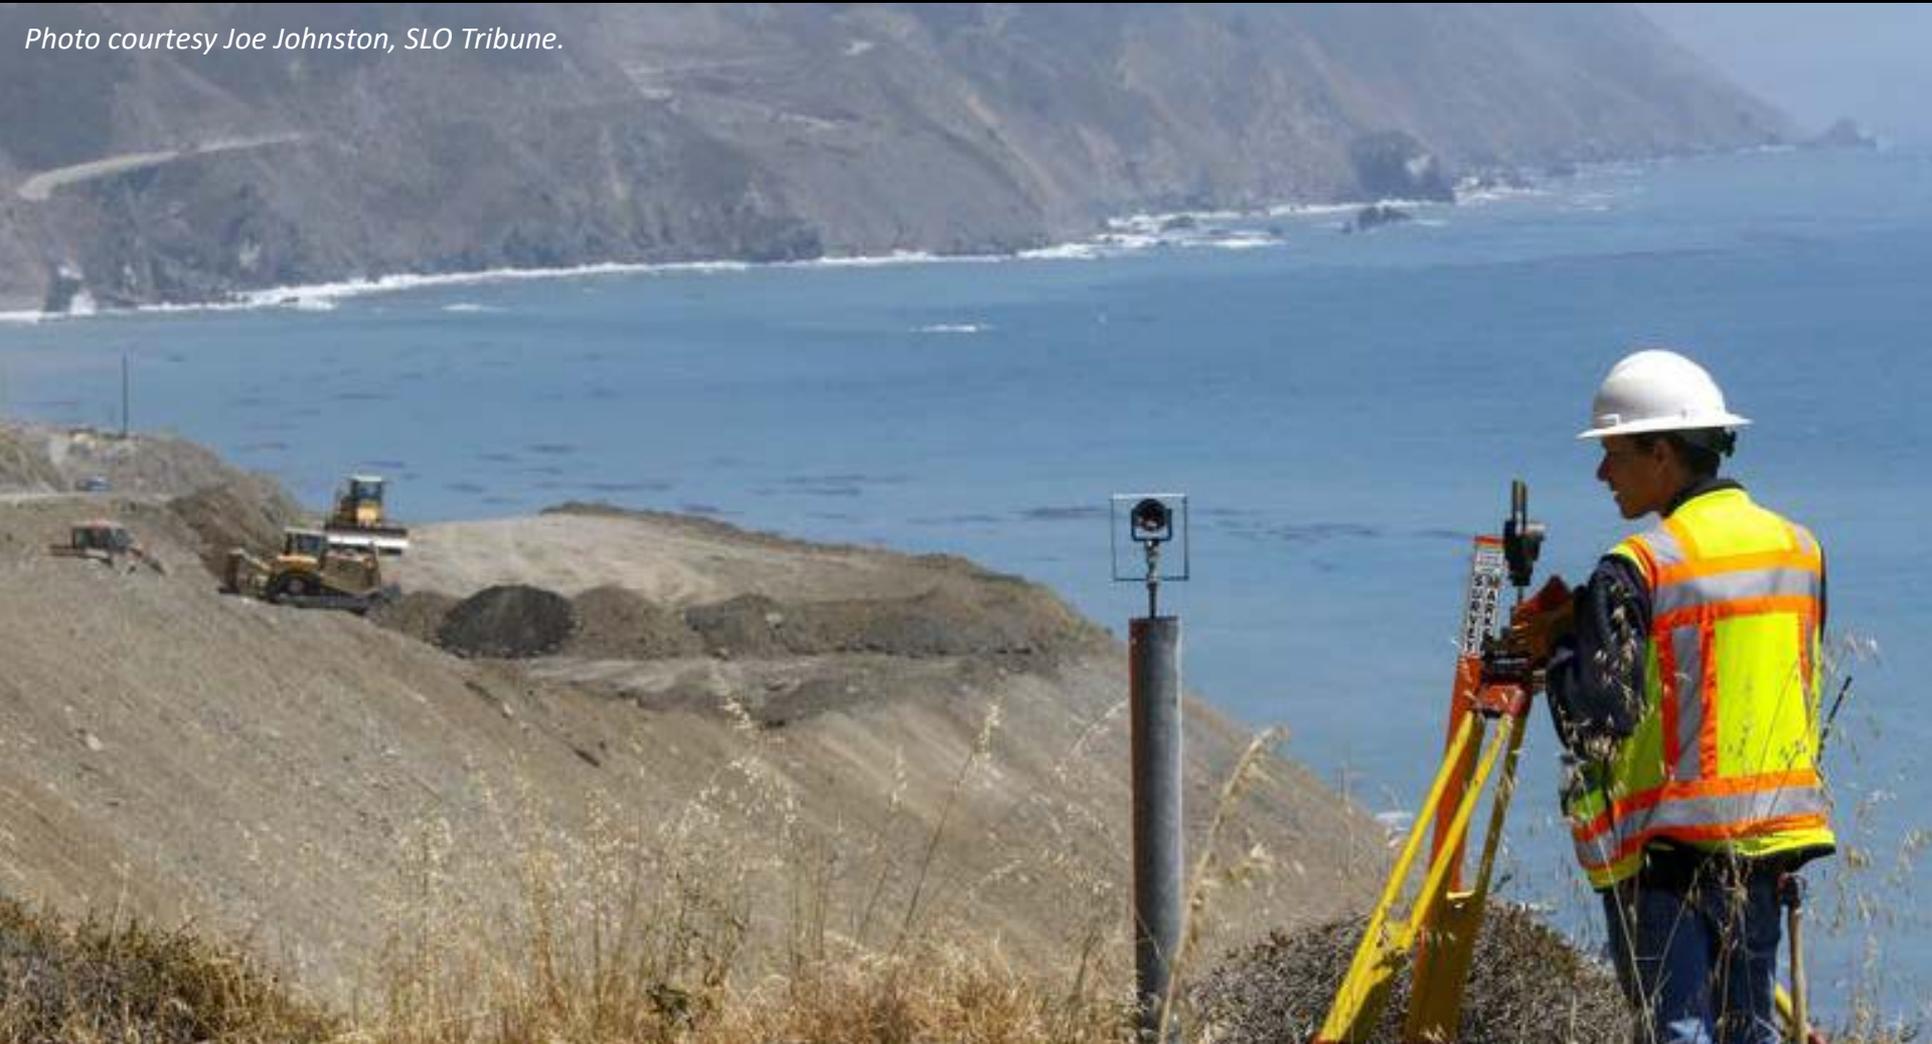
Geotechnical Engineers and Surveyors monitor the surface and subsurface.

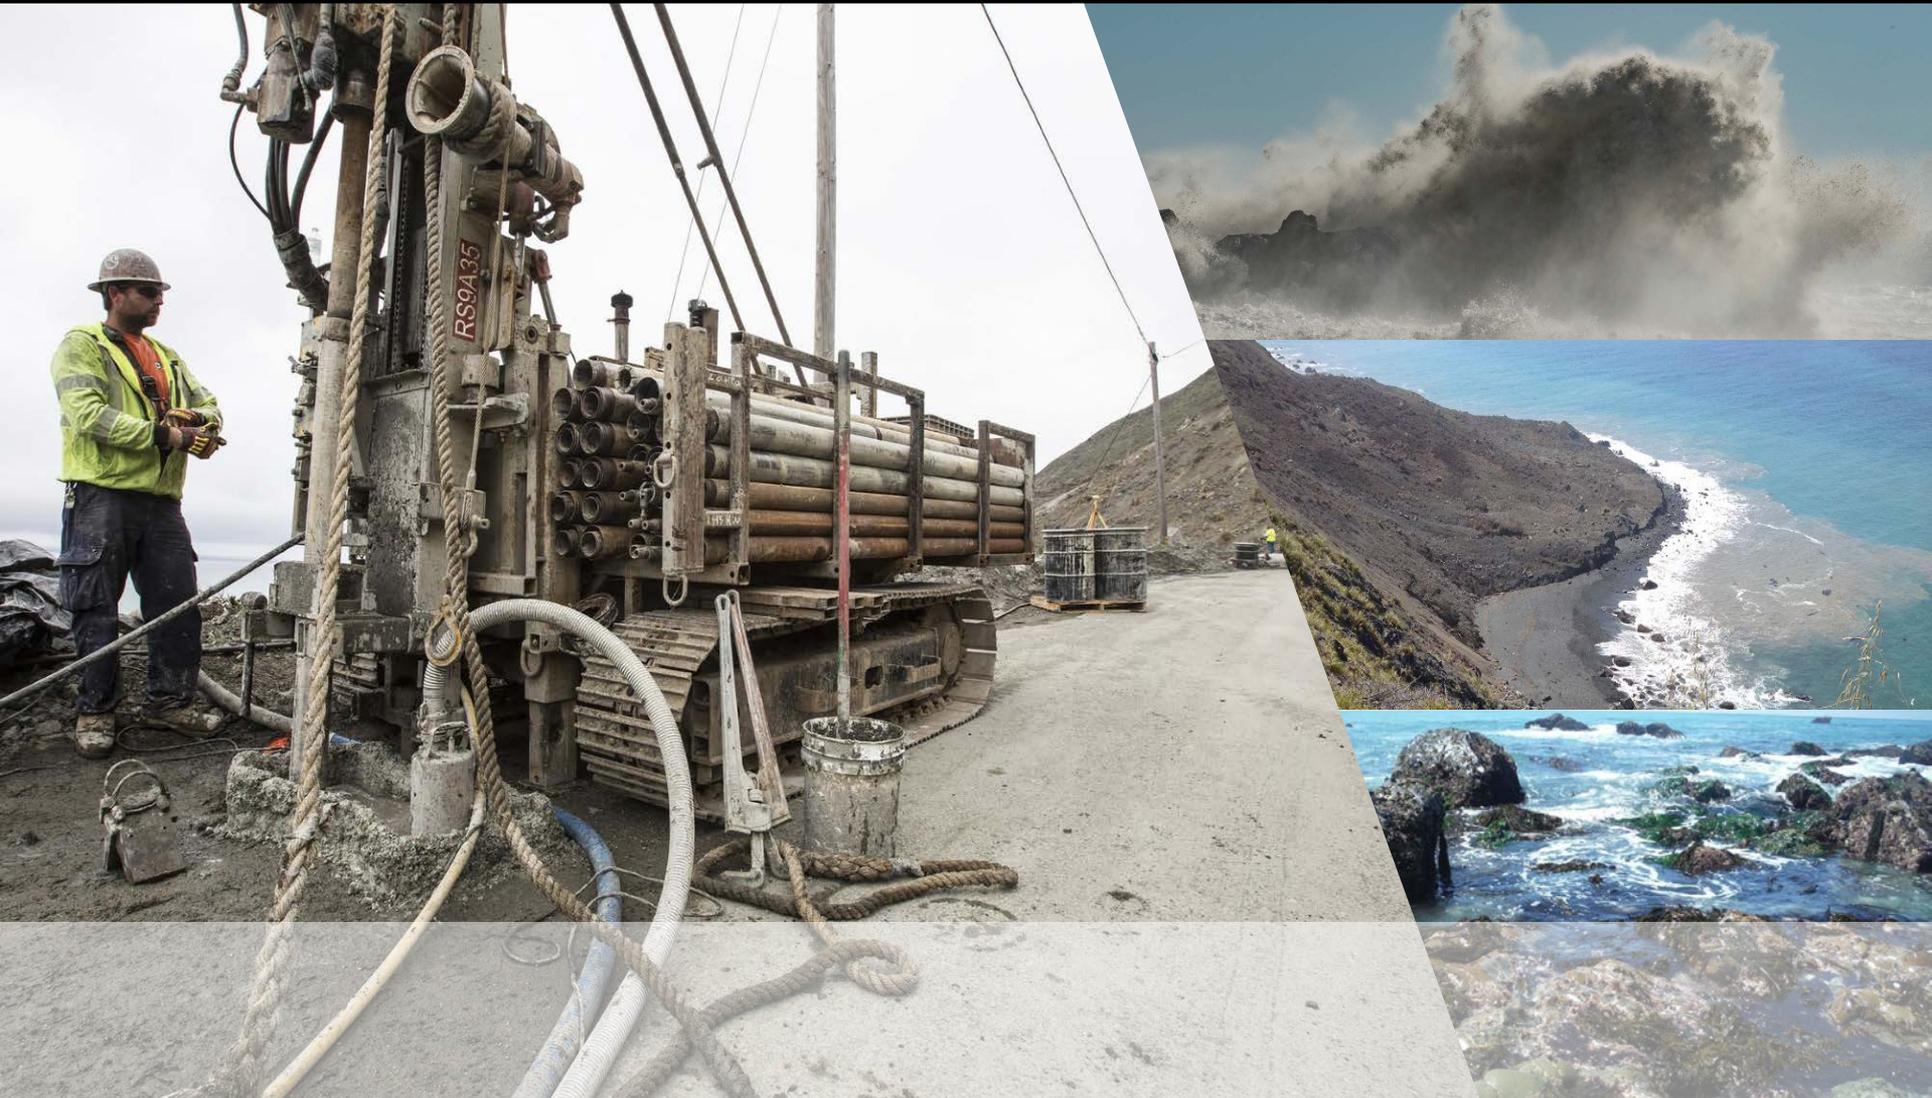
Erosive power of the ocean reduces area for alignment and contributes to sediment into critical habitat

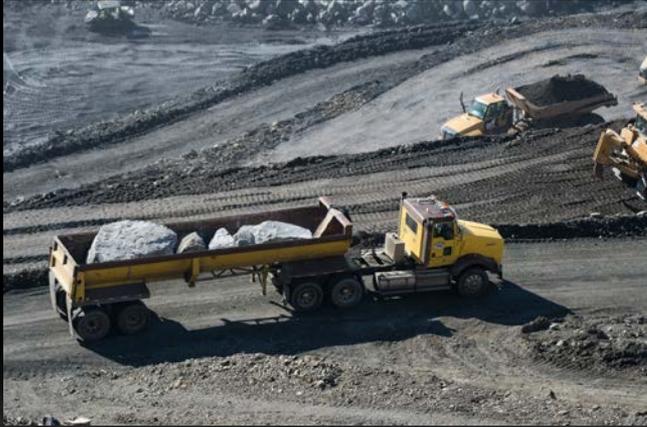
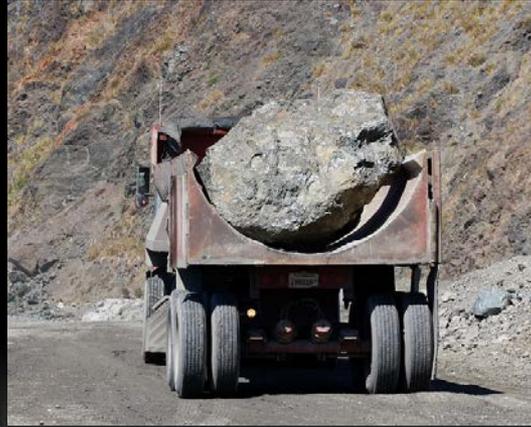
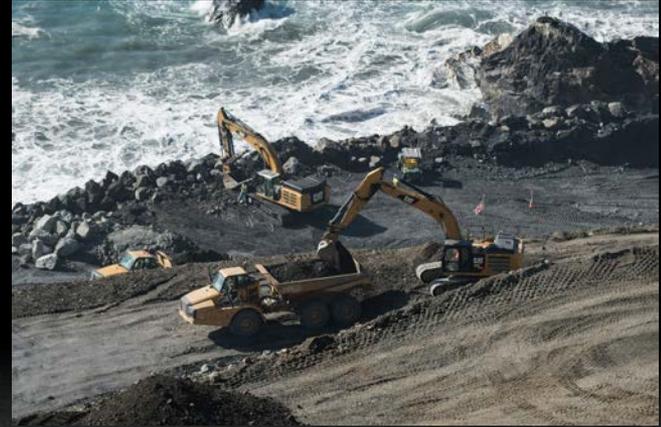
Rocks of up to 8 tons each were hauled to the jobsite and placed individually along the 200+ foot long base. The revetment is 40 feet tall and 60 feet wide, totaling 200,000 tons.

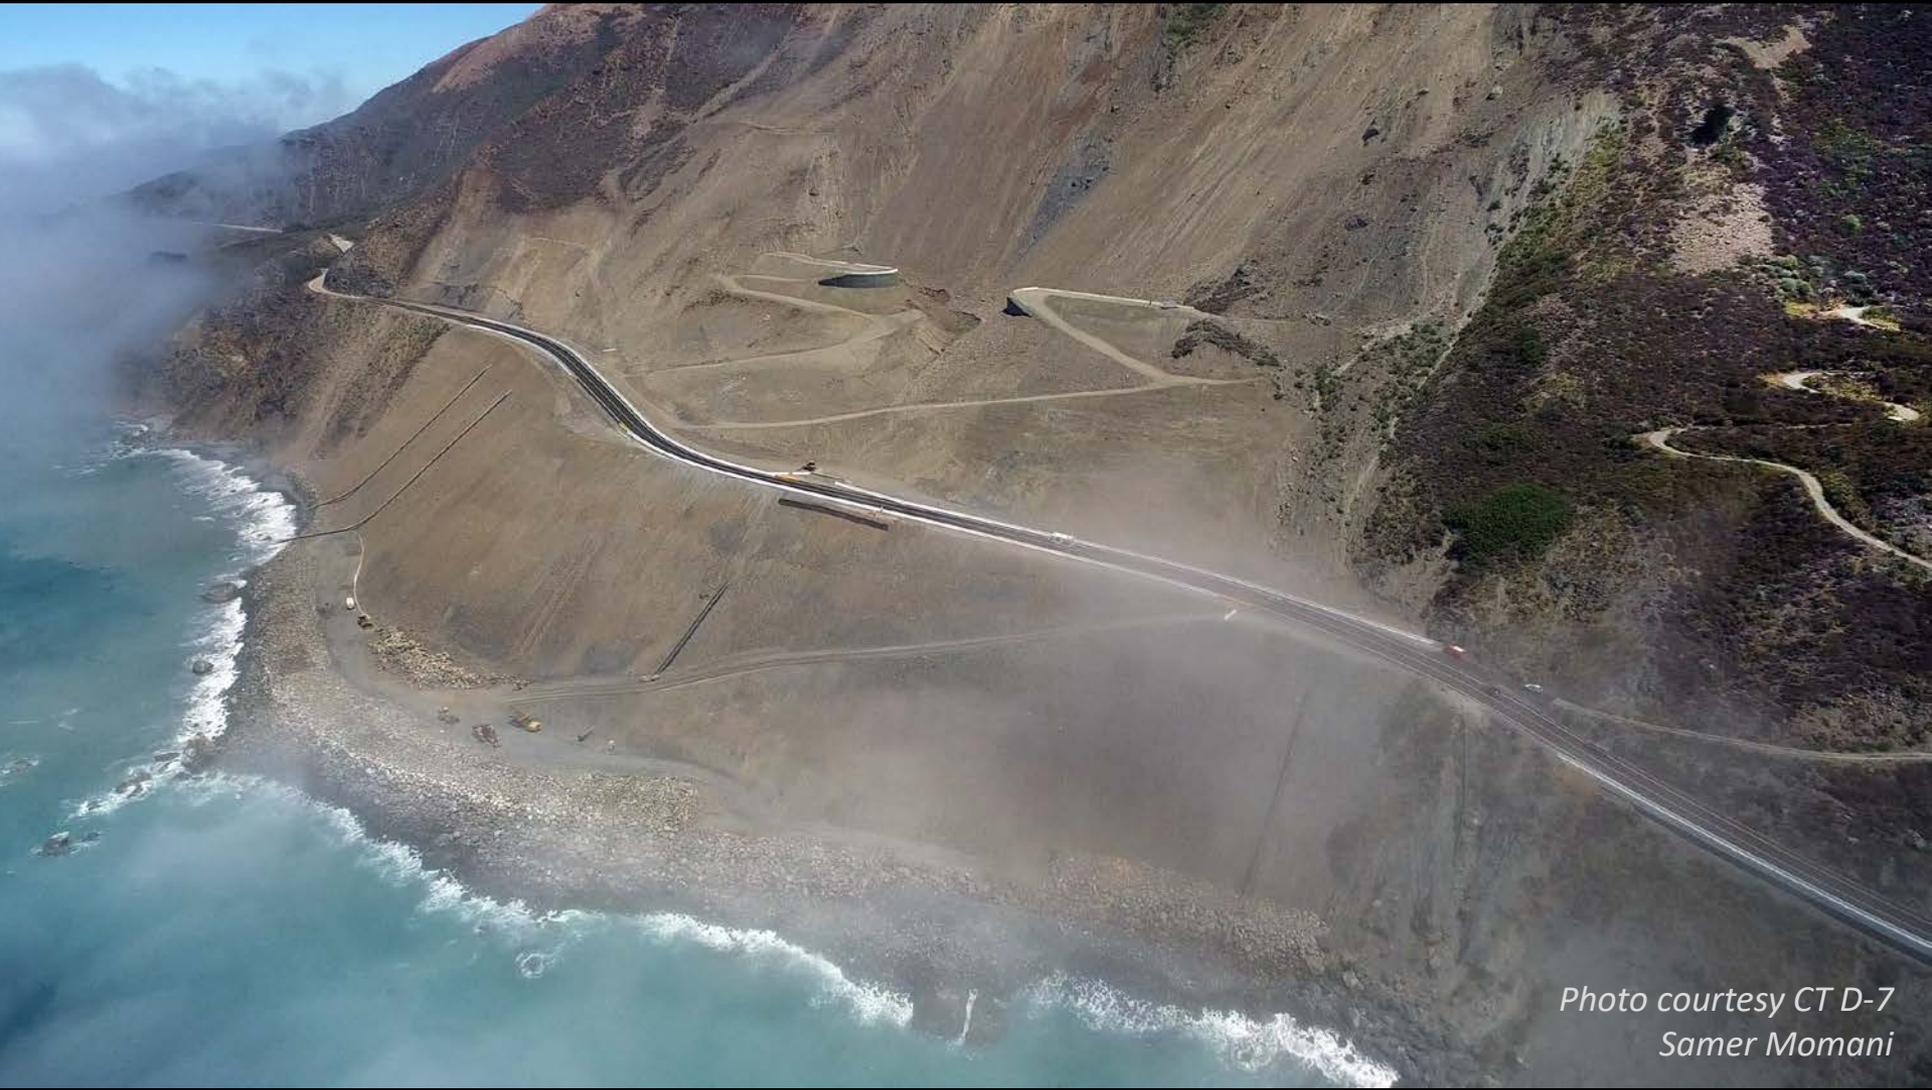
The new ¼ mile roadway is realigned across the Mud Creek landslide on Highway 1 and is buttressed with a series of reinforced embankments, berms, retaining walls, culverts, rock revetment and netting.

These aerial views showcase the innovative design, engineering and construction.
